# Black Dog Manufacturing

## Instruction Manual Rover Engine Block Tester

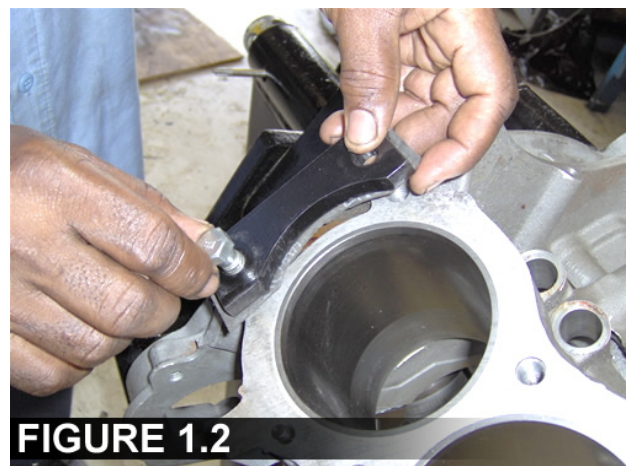
- 1) Remove both cylinder heads.
- 2) Remove the water pump.
- 3) Clean the block surface in the same manner you would to reinstall new head gaskets.
  - a. **!!Important!!**: Do not use high-speed discs of any kind to clean the block surface. Damage to the surface will occur and may prevent head gasket sealing.
- 4) Apply a thin coat of Permatex ultra gray around coolant port on top of the block surface. (Or you may cut a gasket to fit the plates.)
- 5) Install the Black Dog Block Off Plates to the front and back of both cylinder banks using the bolts provided. Torque the bolts to 40 foot-pounds. (Figures 1.1 and 1.2)

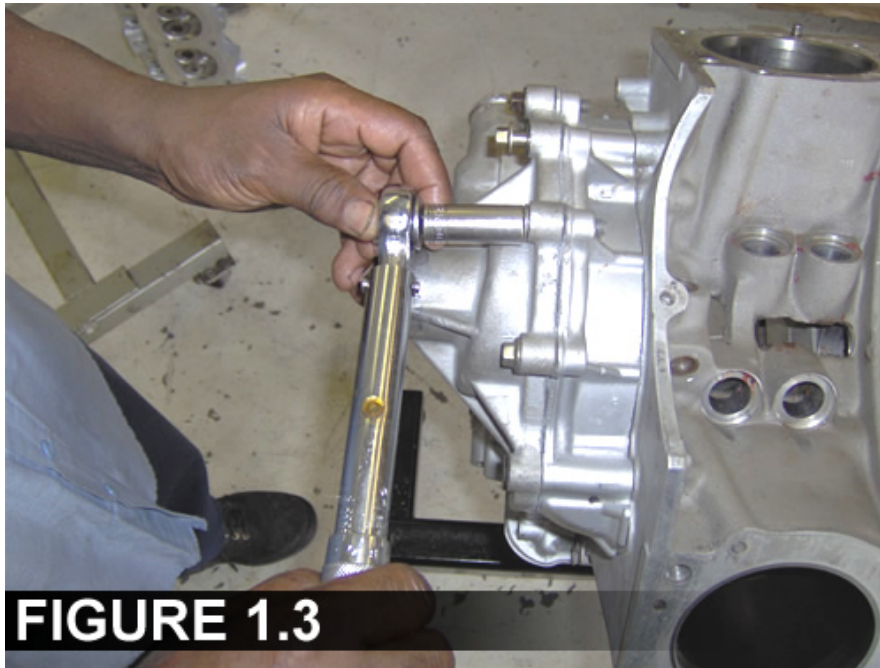
6) Install the modified water pump with gasket provided. Torque to 18 foot-pounds. (Figure 1.3)

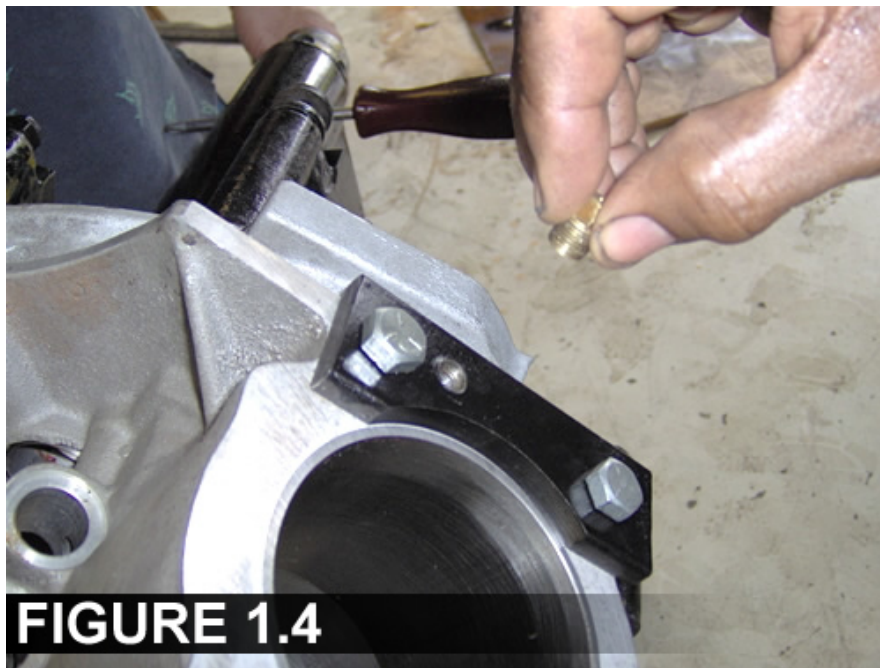
7) Fill the block with 50/50 coolant (you may re-use the old coolant) through the holes in the plates (Figure 1.4). Insure the block is completely full and that there is no air in the cooling system.
