Black Dog Manufacturing

Battery Terminal Repair Kit

**LR3 2005 to 2009 LR4 2010 to 2016 & Range Rover Sport
2010-2013**

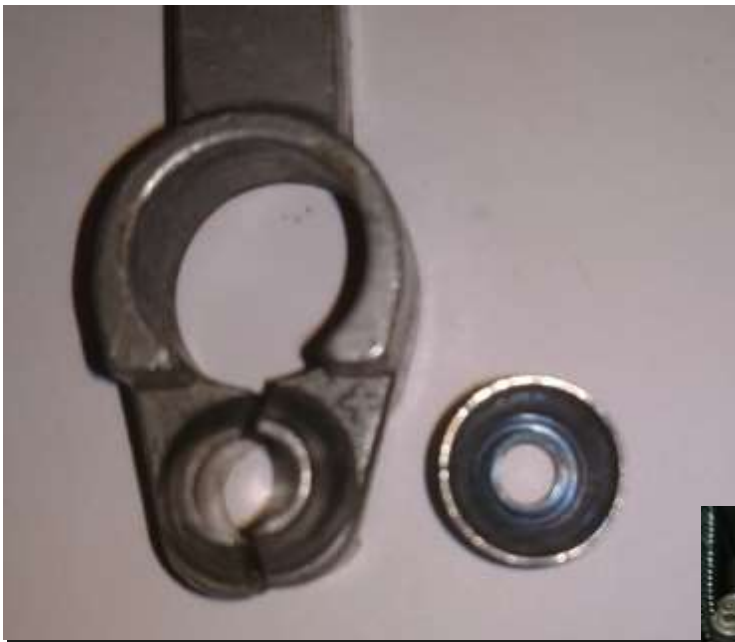
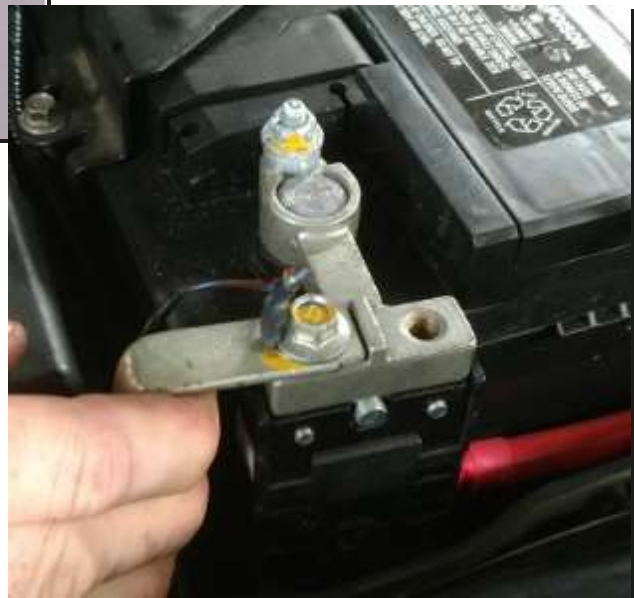
When your Positive battery terminal (cup and cone) wears out and no matter how tight you get it just will not tighten down

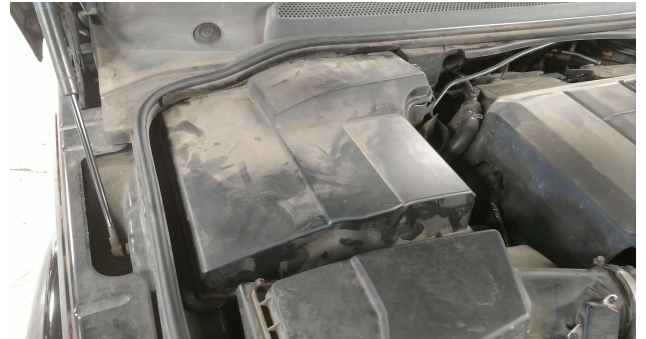
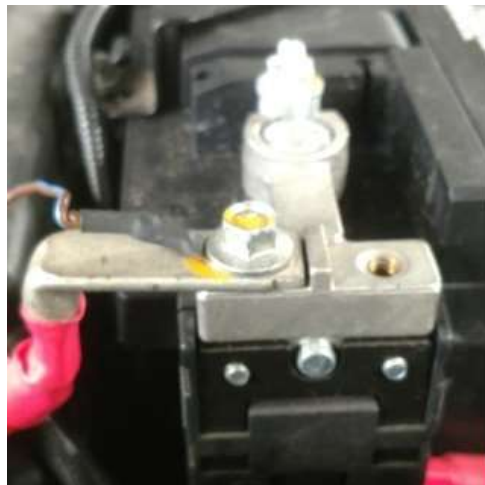
First: Remove battery cover and you will see the Positive terminal and block that houses the 450 amp fuse.

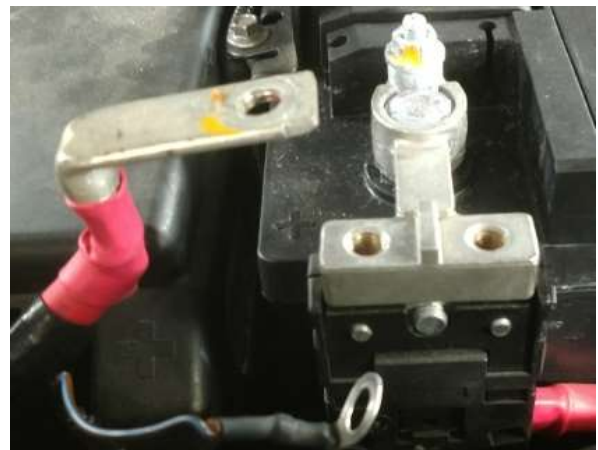
Second: Remove the negative battery terminal and set aside.

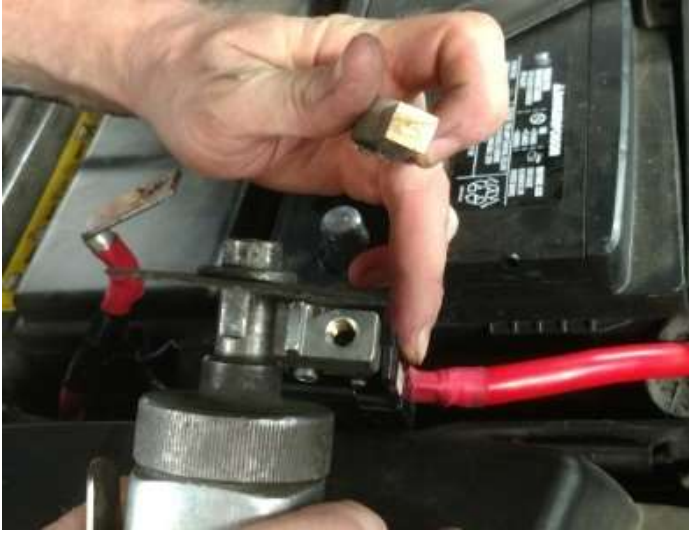
Thrid: Remove cables and set aside.

Then cut the head off right at the block.

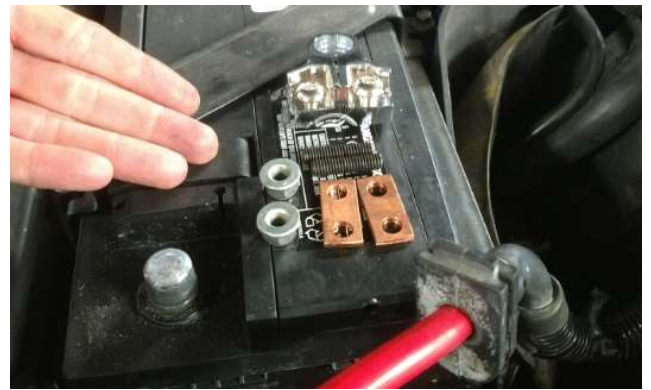
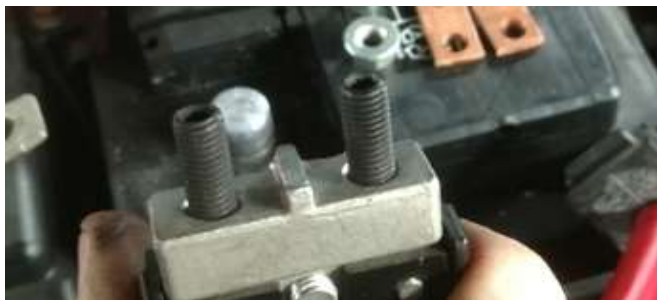
In the kit you will have a new battery terminal
two copper plates two Allen head studs and two
flanged nuts.

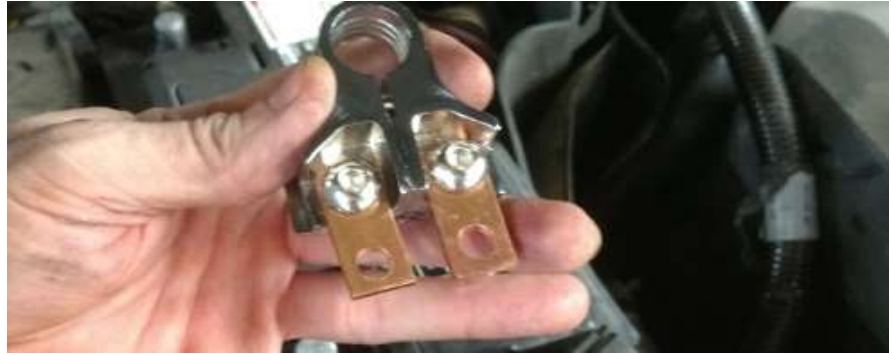
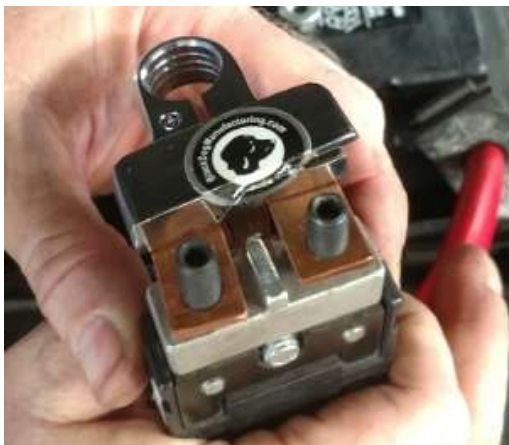
Fouth: Install the two supplied studs
Allen head side up so you can tighten
them down

Fifth: Install the two copper plates chamfer side to the new battery terminal but leave them loose.

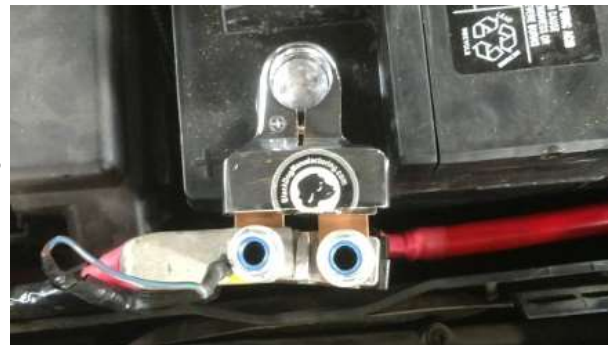
now slide the two copper plates over the studs.

and reinstall the other cables
